**CONCEPTUAL SITE MODEL
FORMER ROMIC ENVIRONMENTAL TECHNOLOGIES CORP. FACILITY
LONE BUTTE INDUSTRIAL PARK
GILA RIVER INDIAN COMMUNITY, ARIZONA**

**Clear Creek Associates, PLC
6155 East Indian School Road, Suite 200
Scottsdale, Arizona 85251**

**February 3, 2011
Project No. 212001**

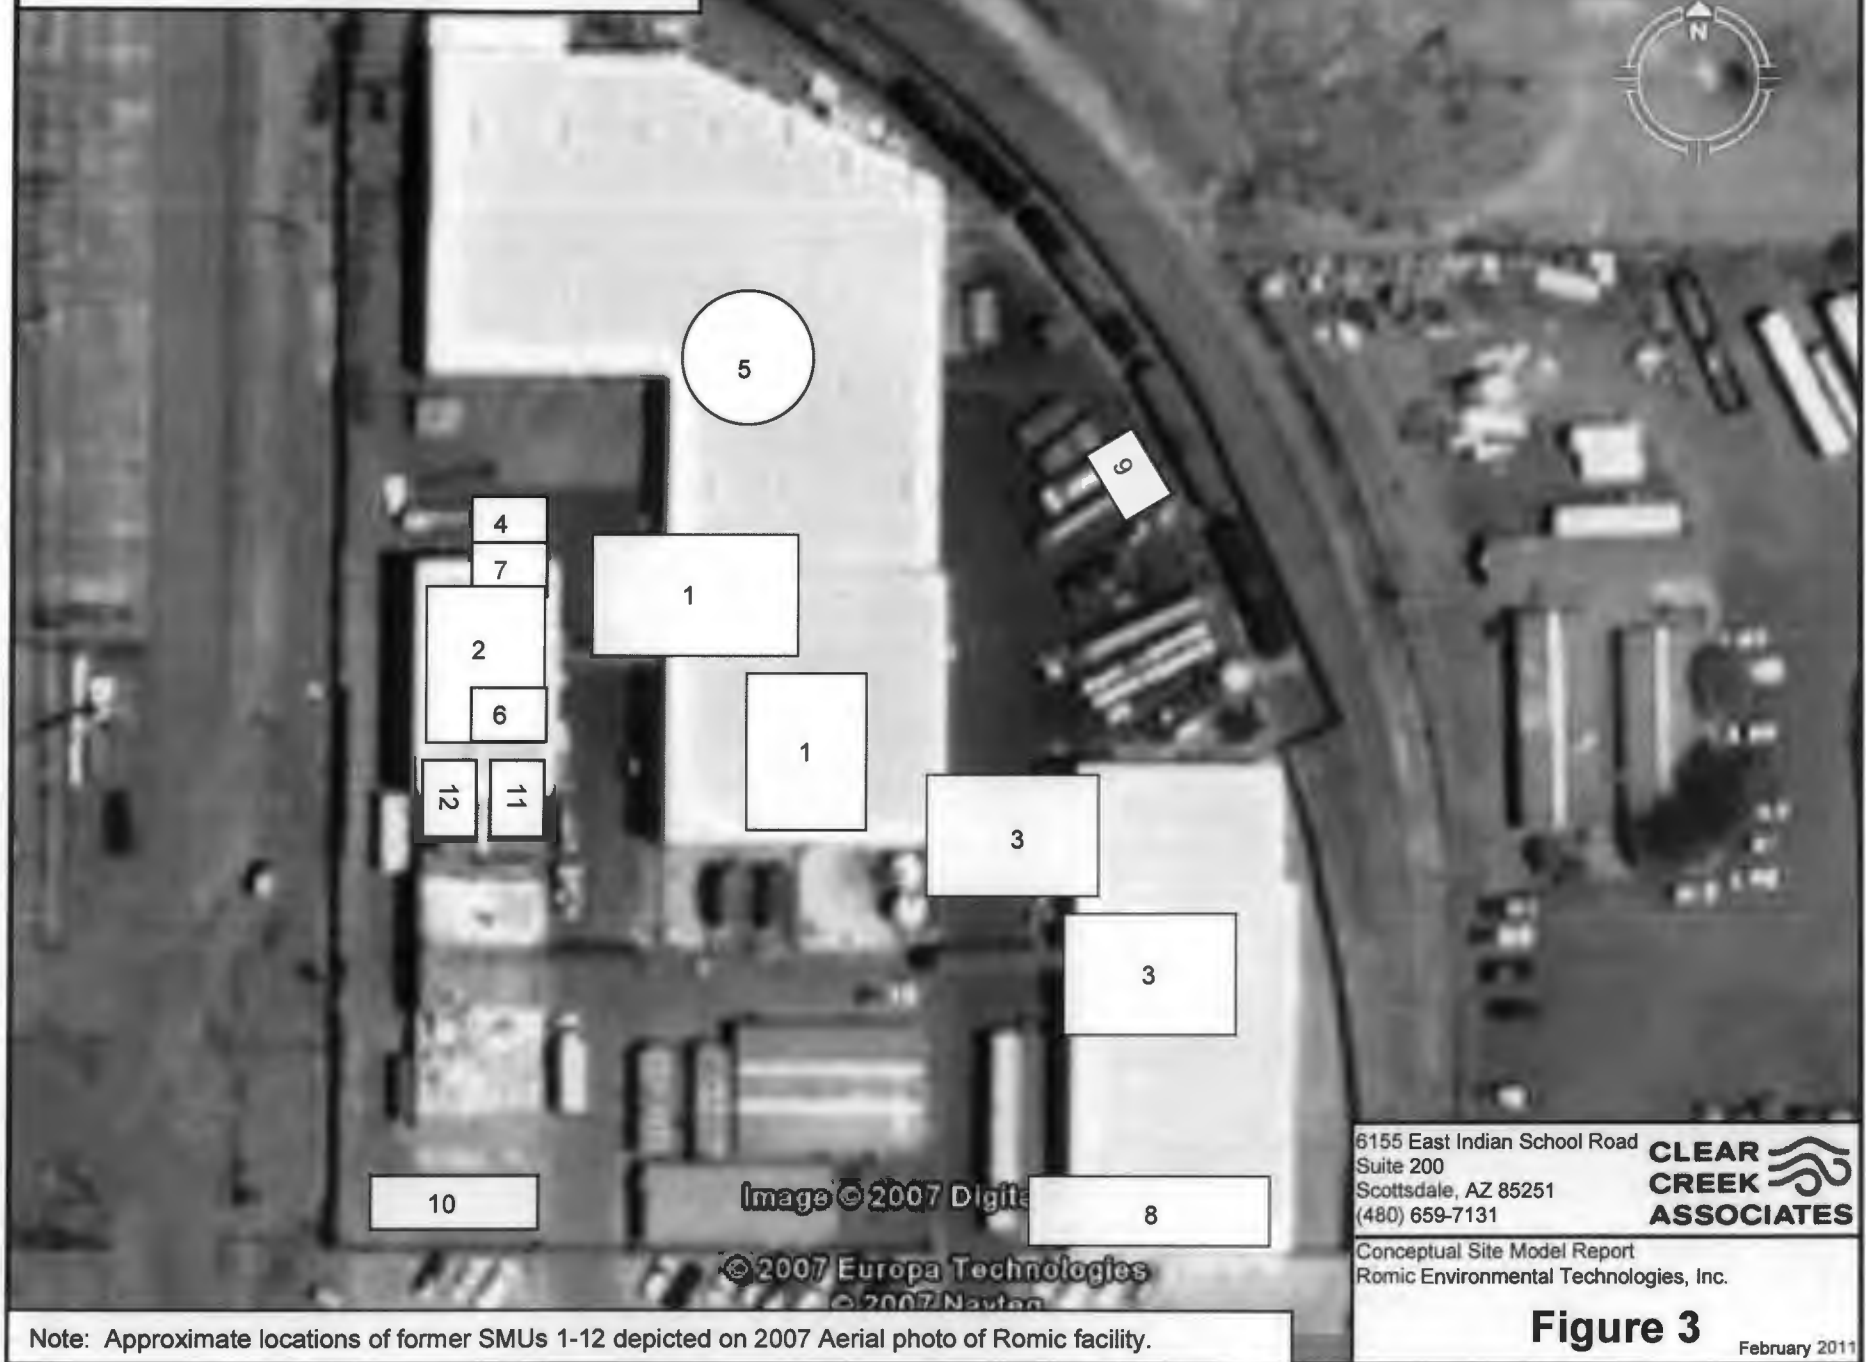
**FORMER SMU LOCATION MAP
(SMUs 1-12)**

Note: Approximate locations of former SMUs 1-12 depicted on 2007 Aerial photo of Romic facility.

shown on Figure 5. A composite aerial photograph from the early 1990s showing the former Romic facility after reconstruction activities were completed is included as Figure 6. Additional information regarding the SMUs is presented in Clear Creek Associates' August 2008 *Current Conditions Report*.

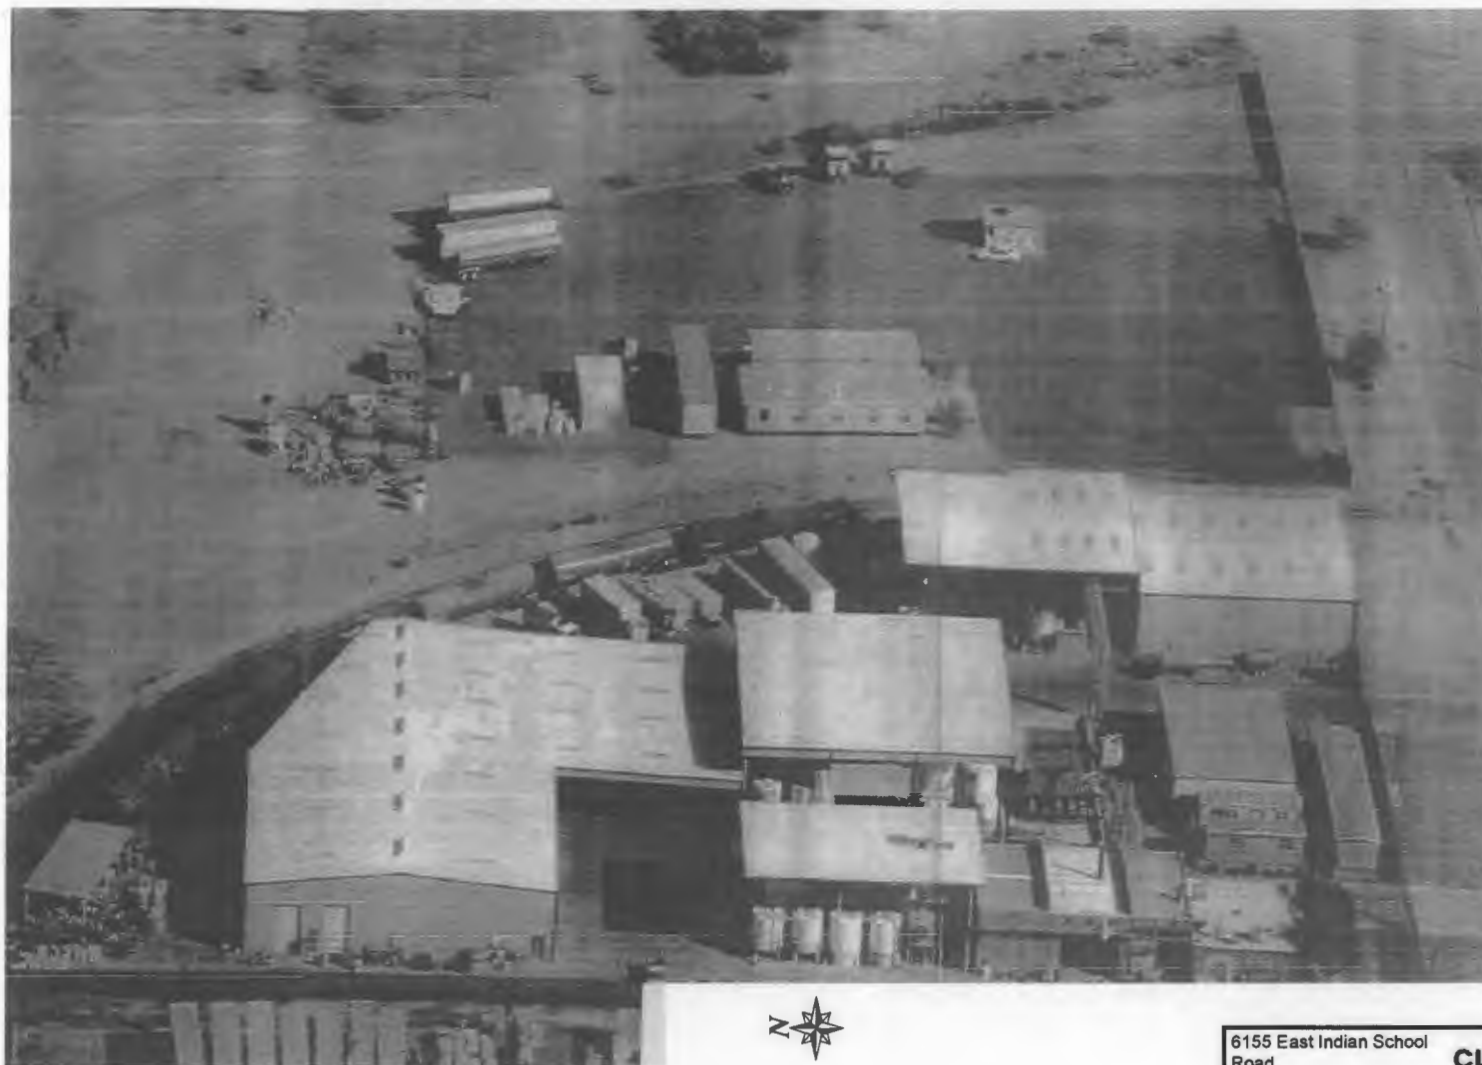
HISTORICAL AERIAL PHOTO (Est. Early 1990s)

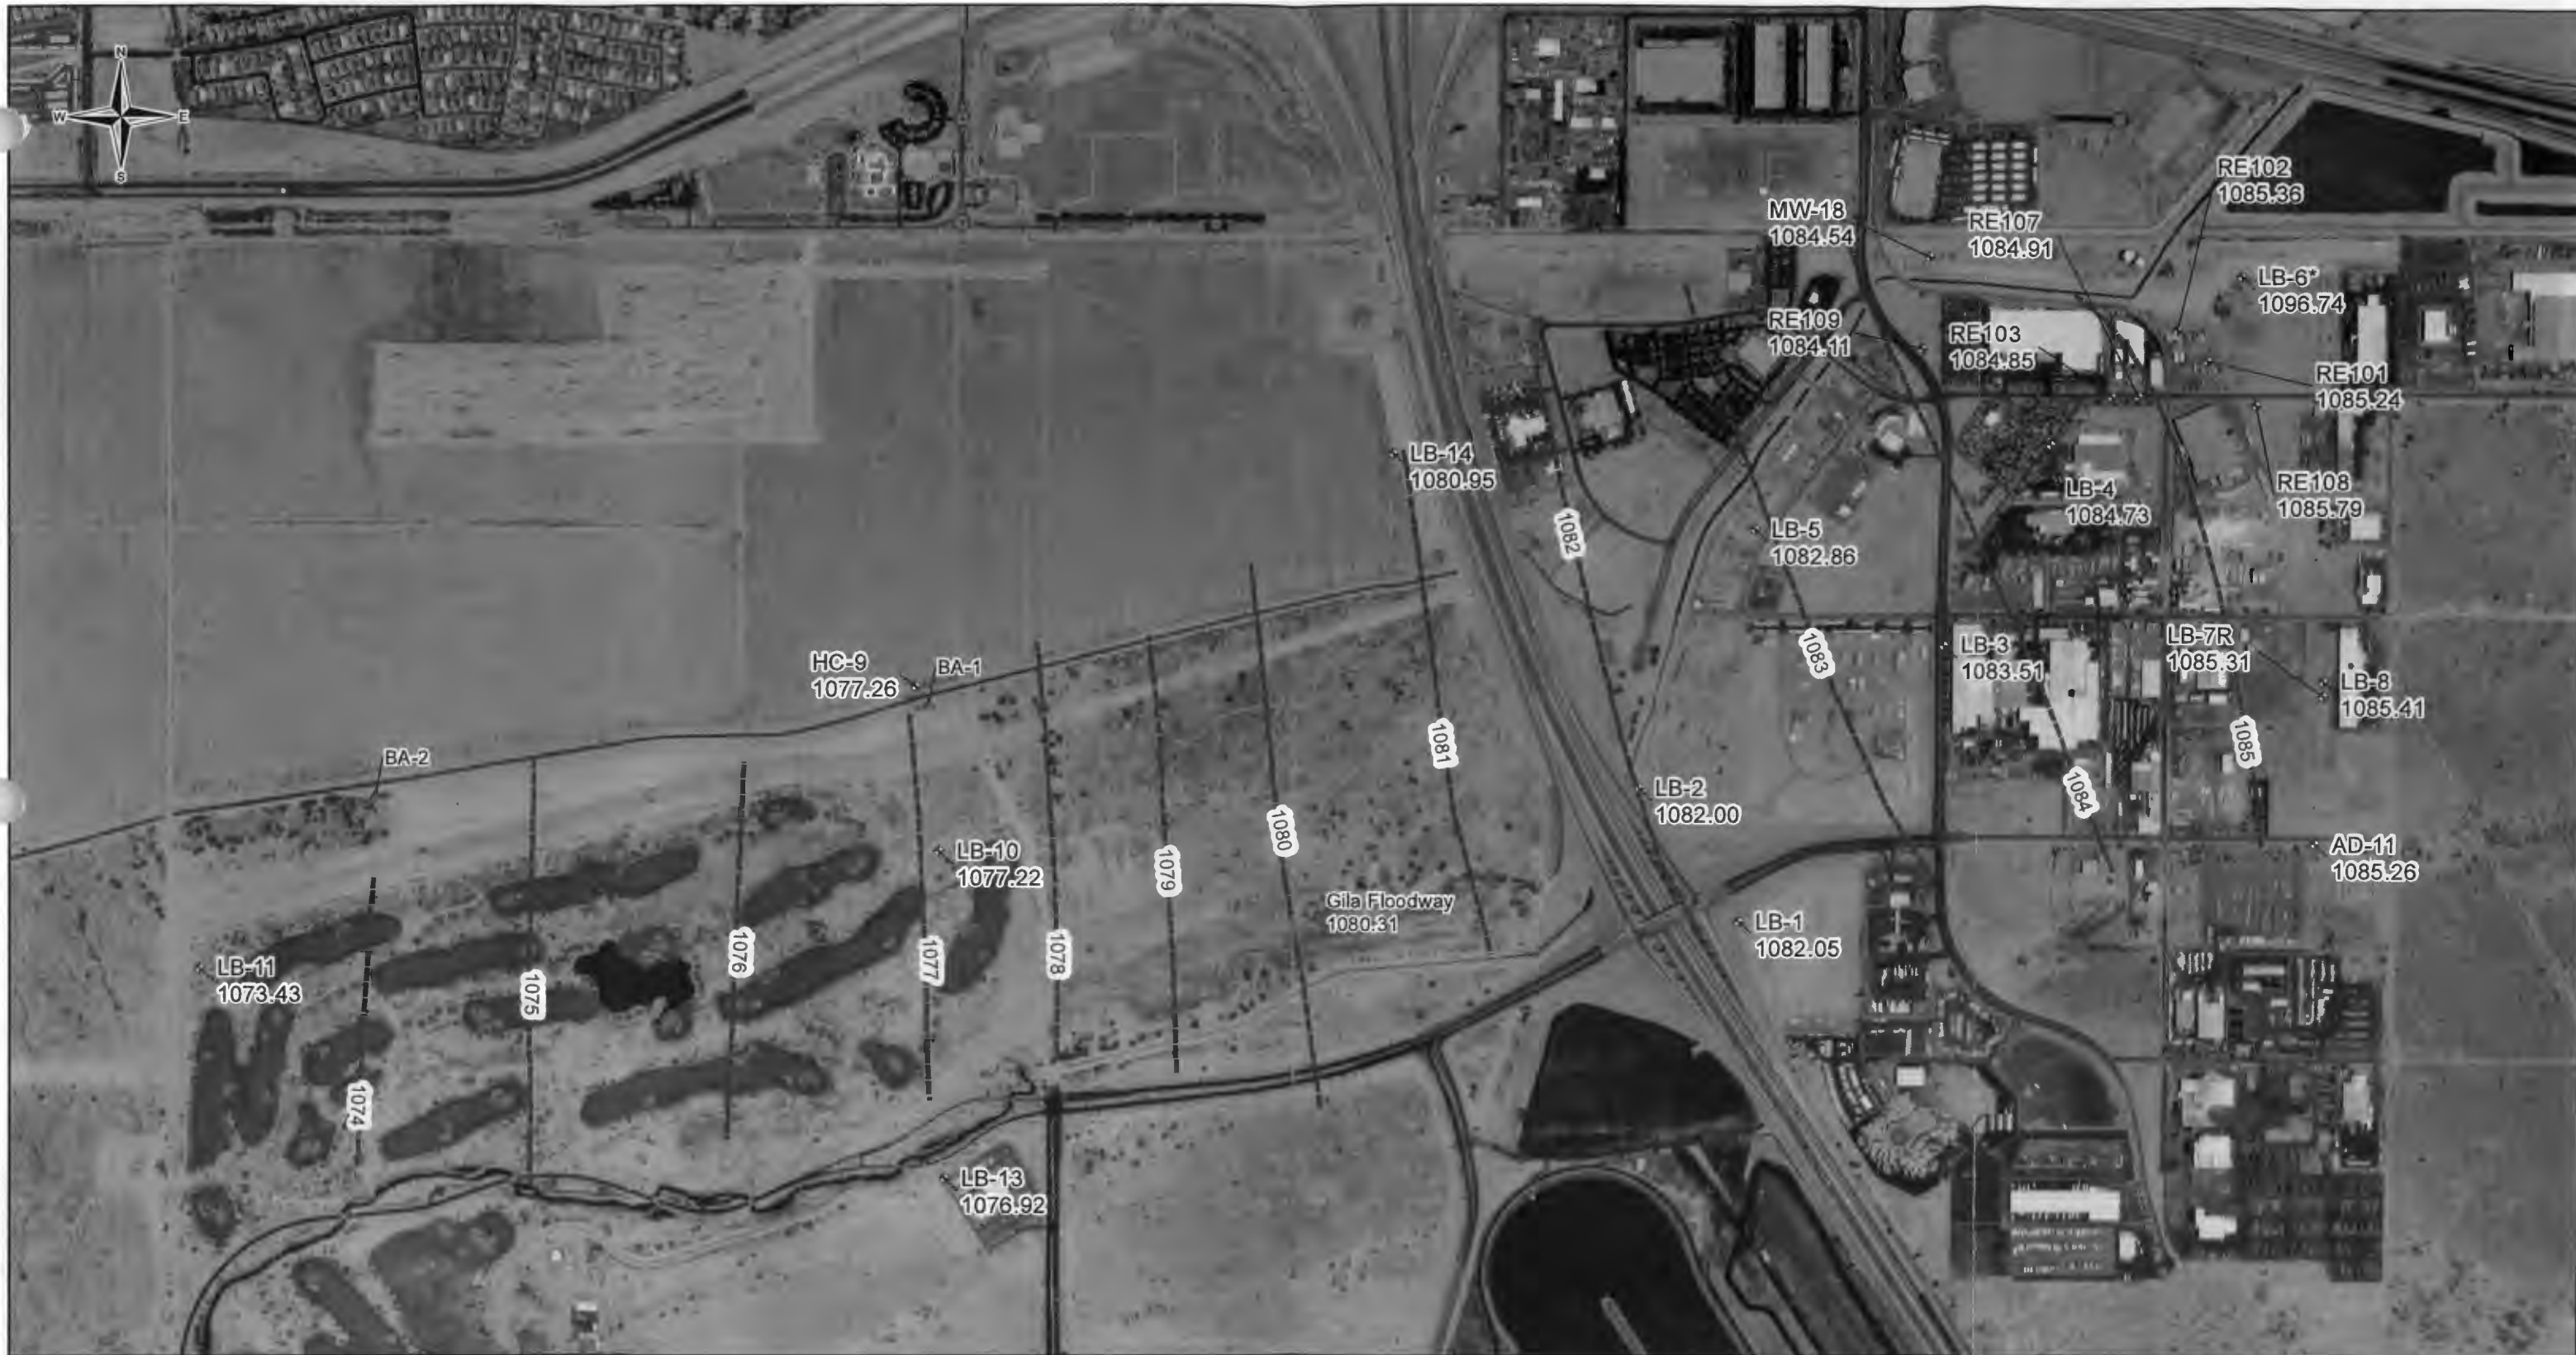
Groundwater Elevations (July 2010)

Regional groundwater occurs in unconfined conditions at a depth of approximately 70 feet bgs. Groundwater flow directions in the regional aquifer, based on the monitoring data collected from the Romic monitor wells (RE101 through RE107) between August 2007 and August 2010, are generally west-southwest (Clear Creek Associates, 2010b). Groundwater elevation contours for July 2010, the most recent study area-wide water level monitoring event, are shown on Figure 11. Historical groundwater elevation data are summarized in Table 3. The

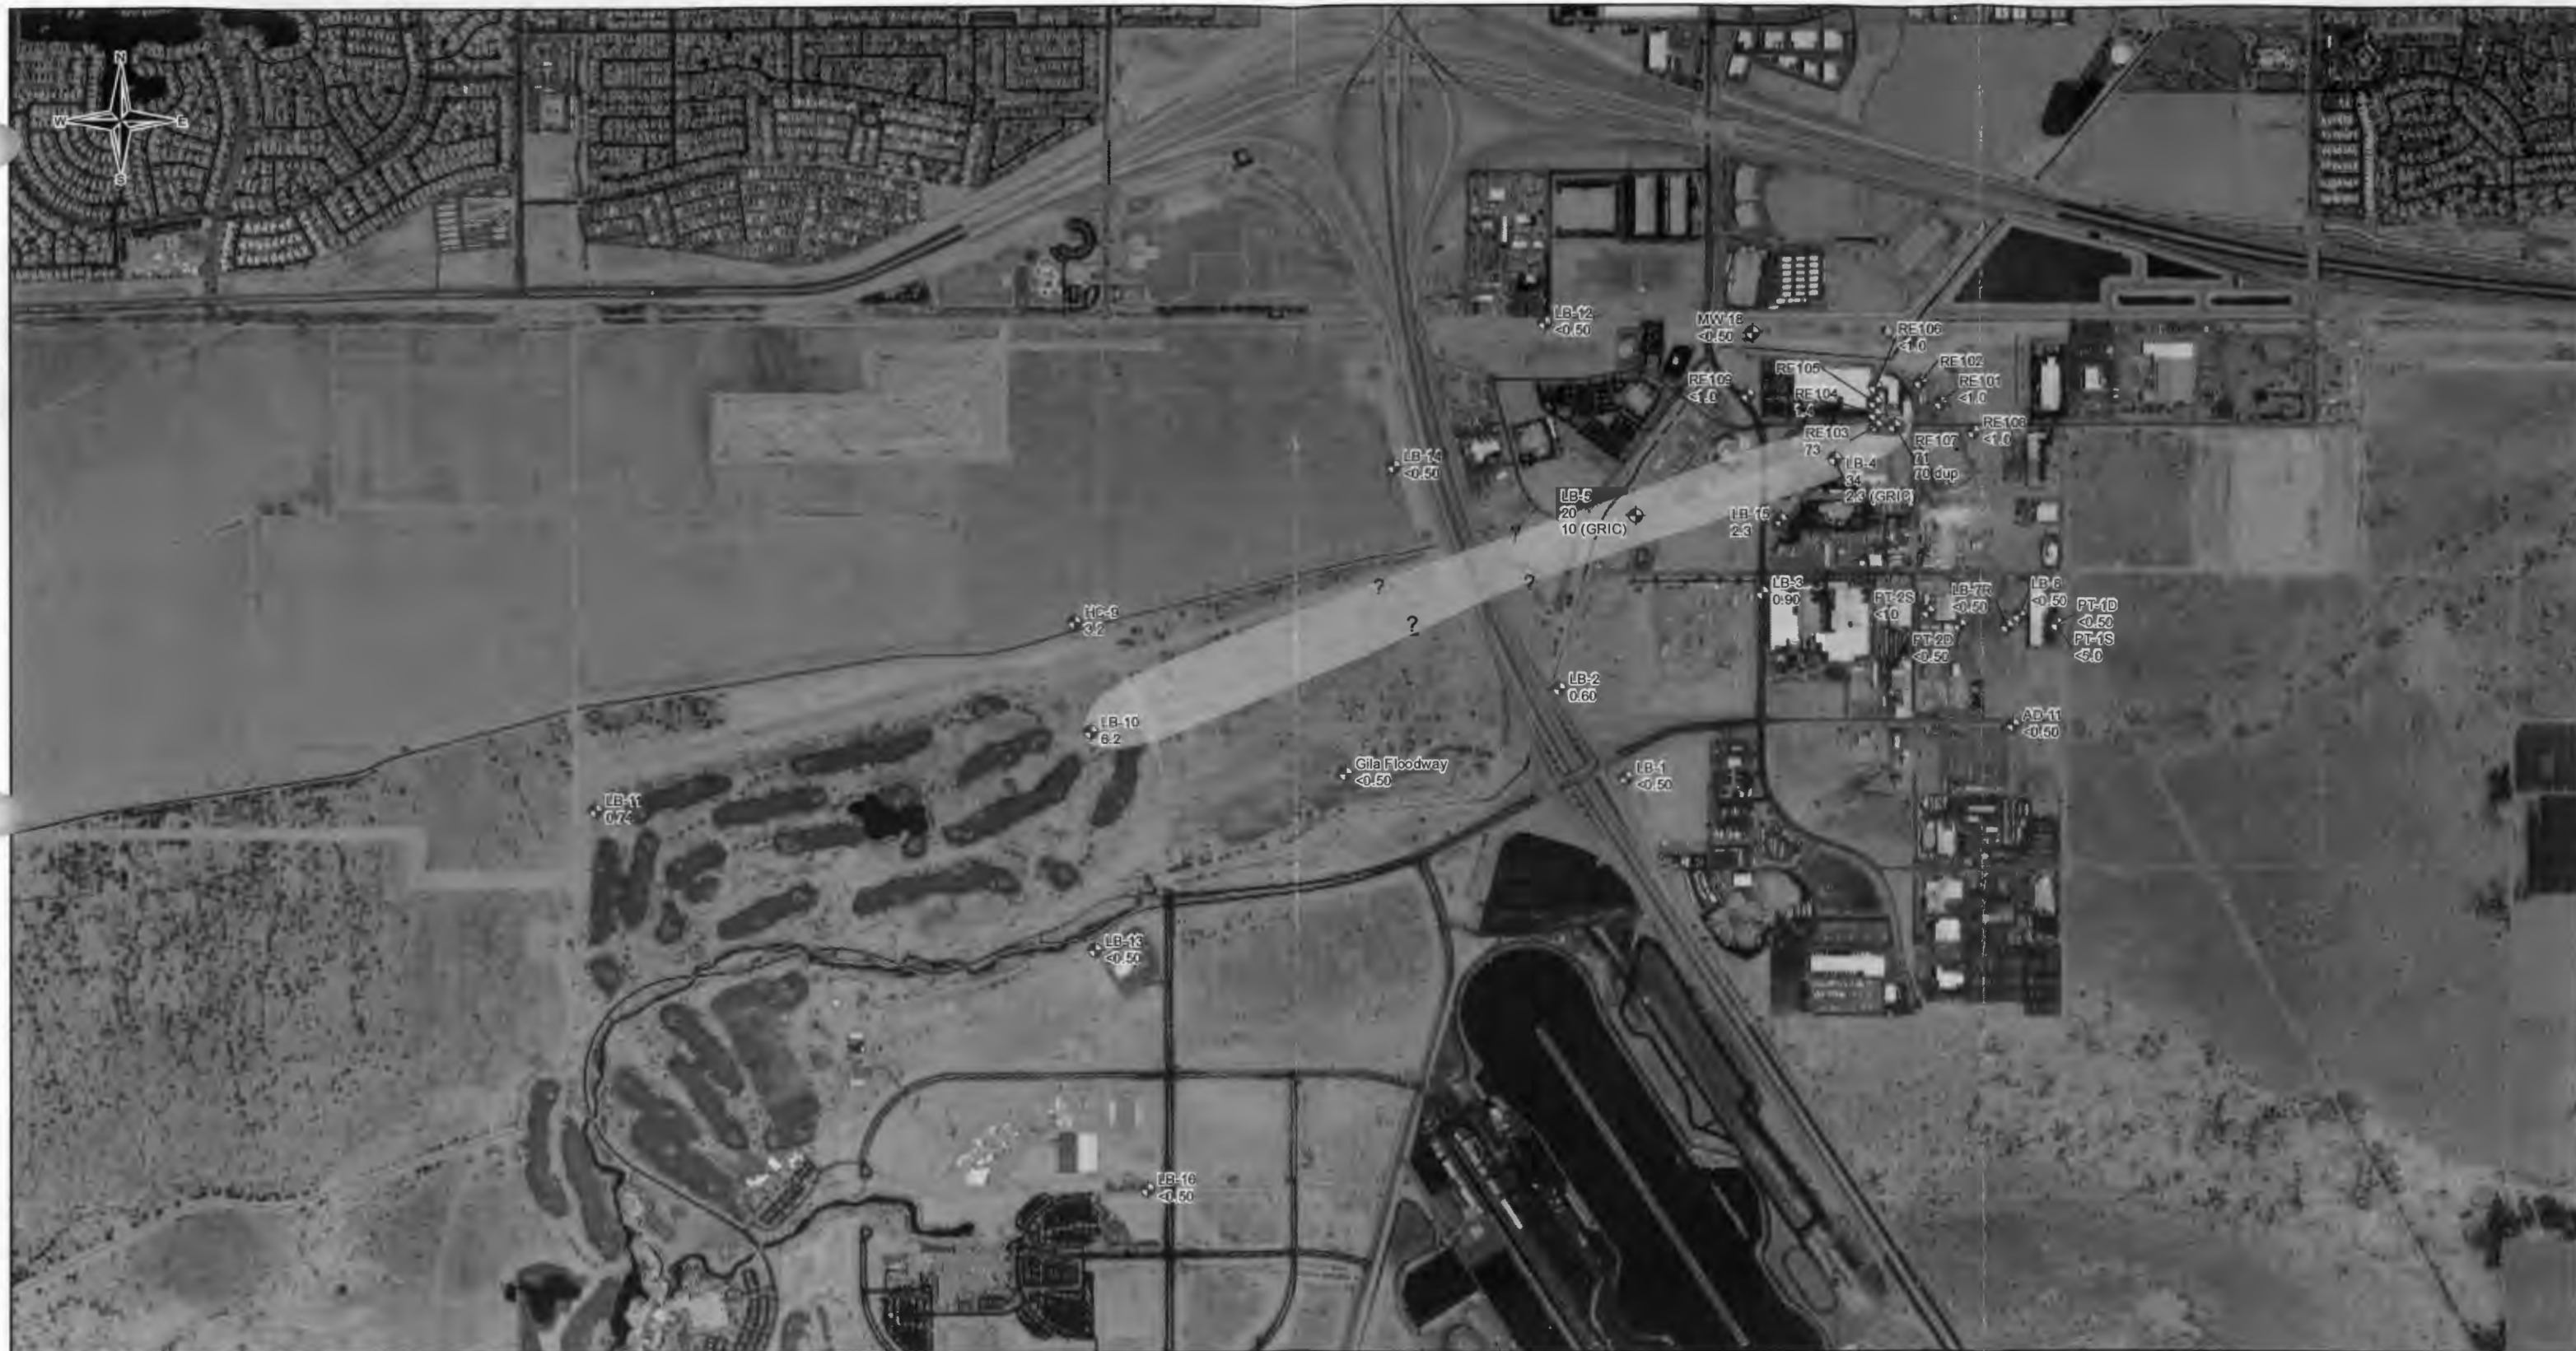
◆ July/August 2010 PCE Concentration (ug/L)

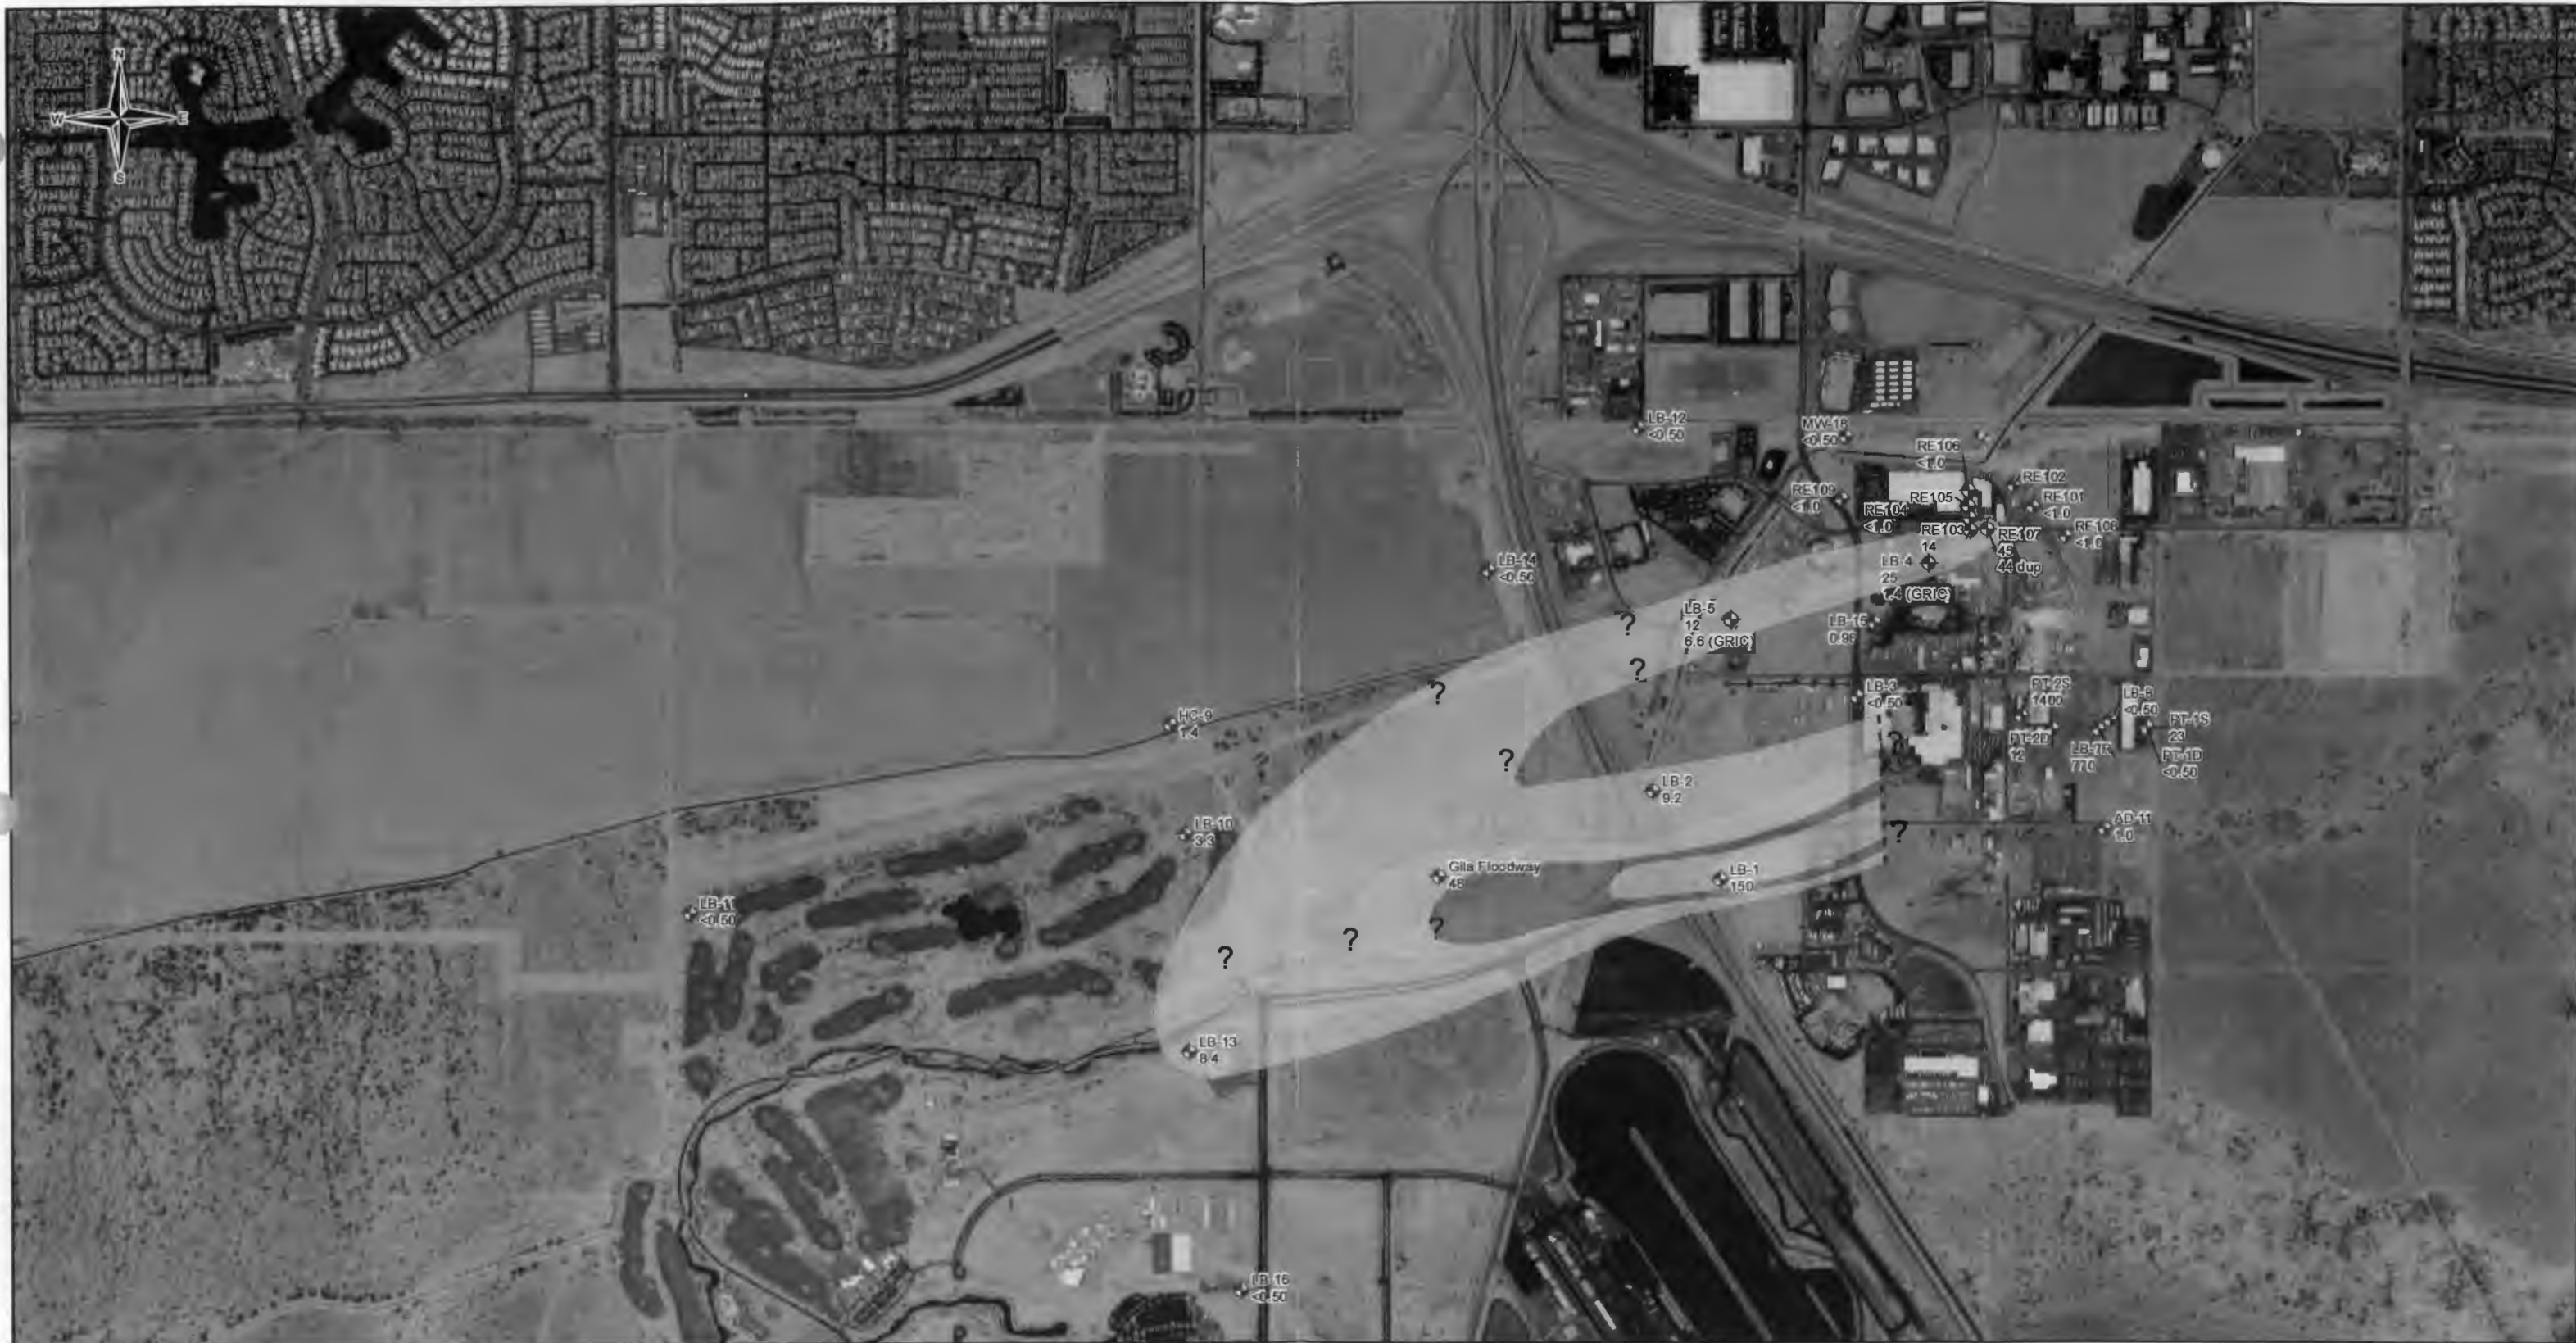
◆ July/August 2010 TCE Concentration (ug/L)

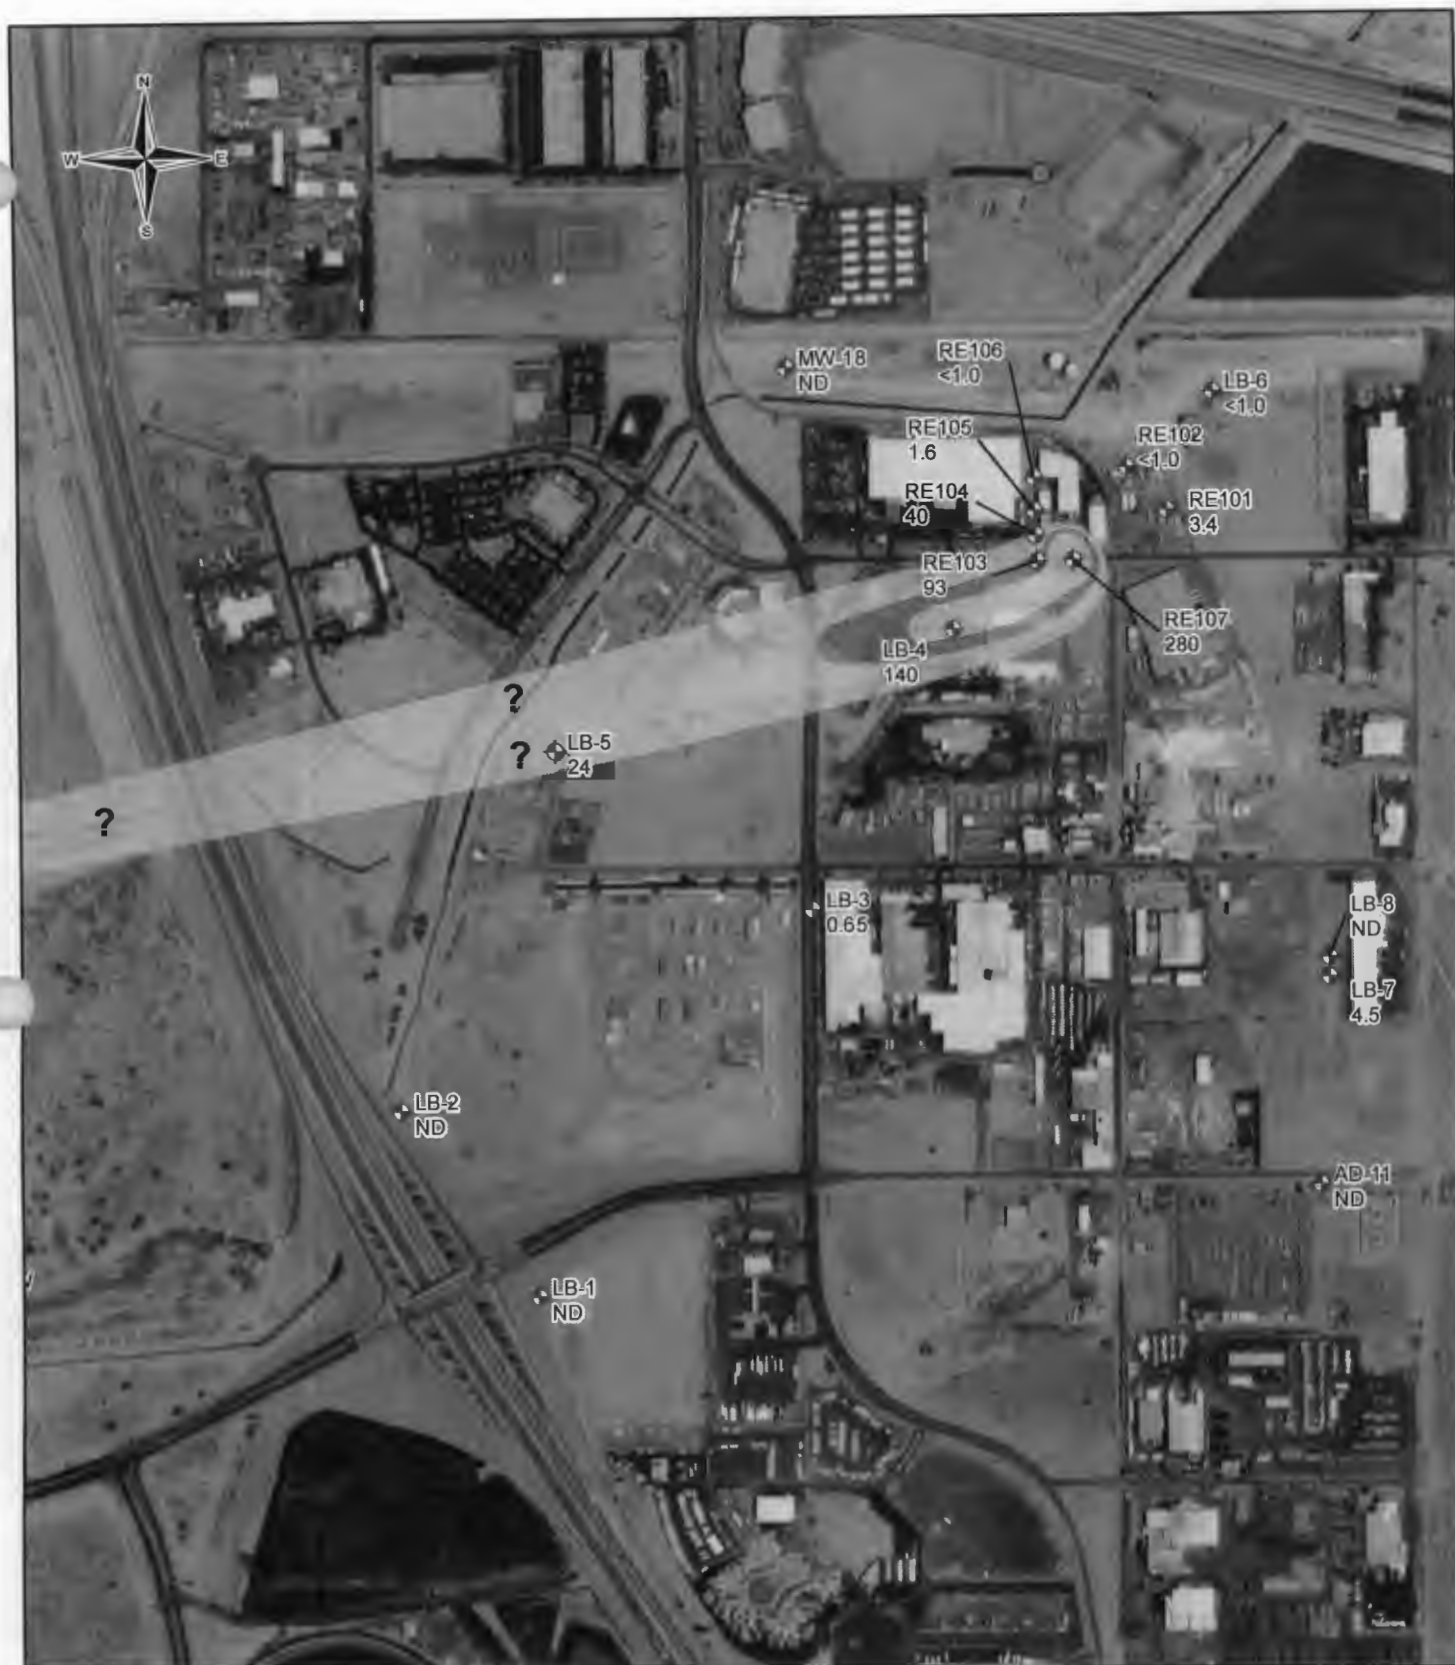
PCE Concentrations – Lone Butte Industrial Park Area (August 2007)

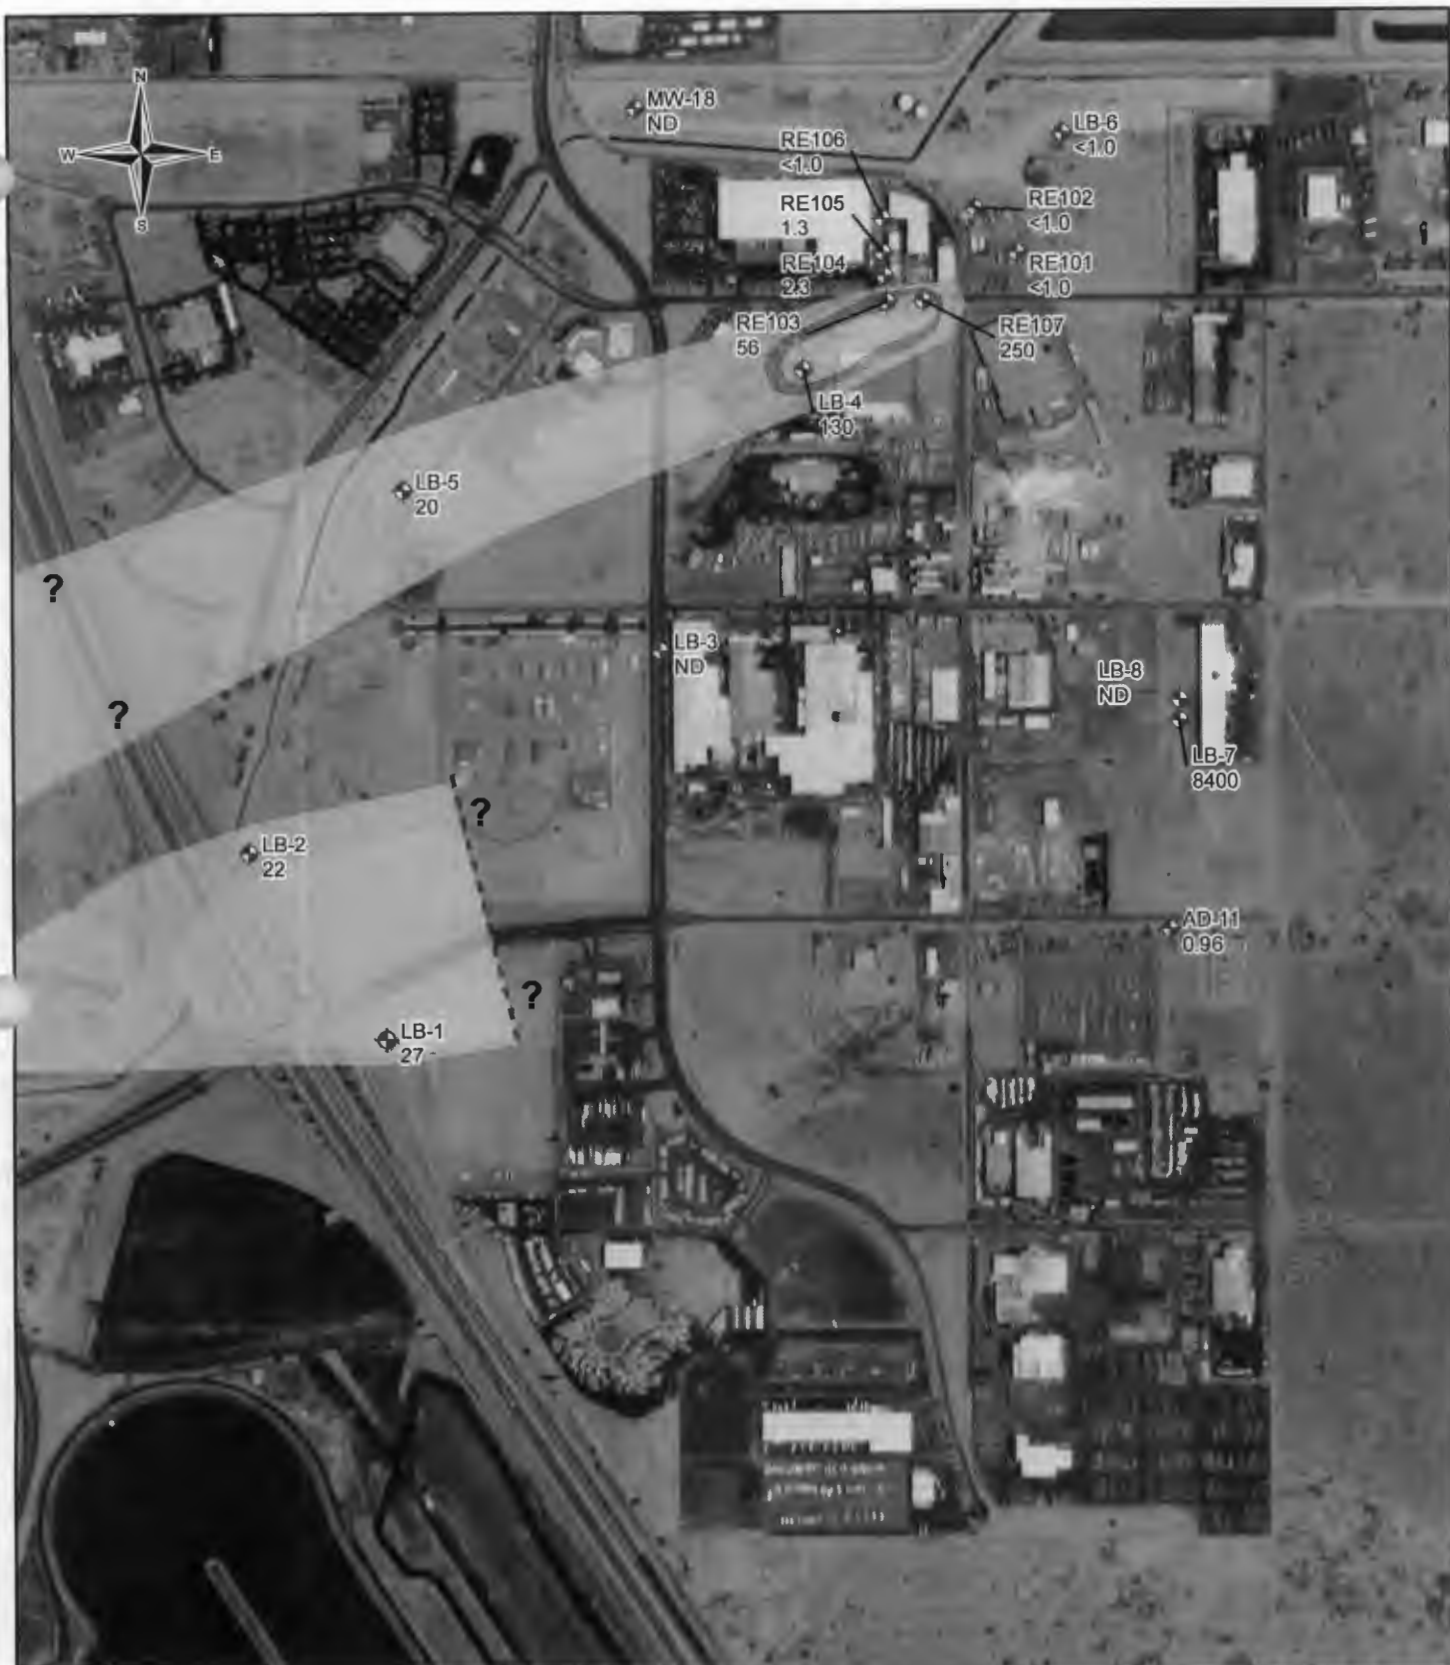
TCE Concentration - Lone Butte Industrial Park Area (August 2007)

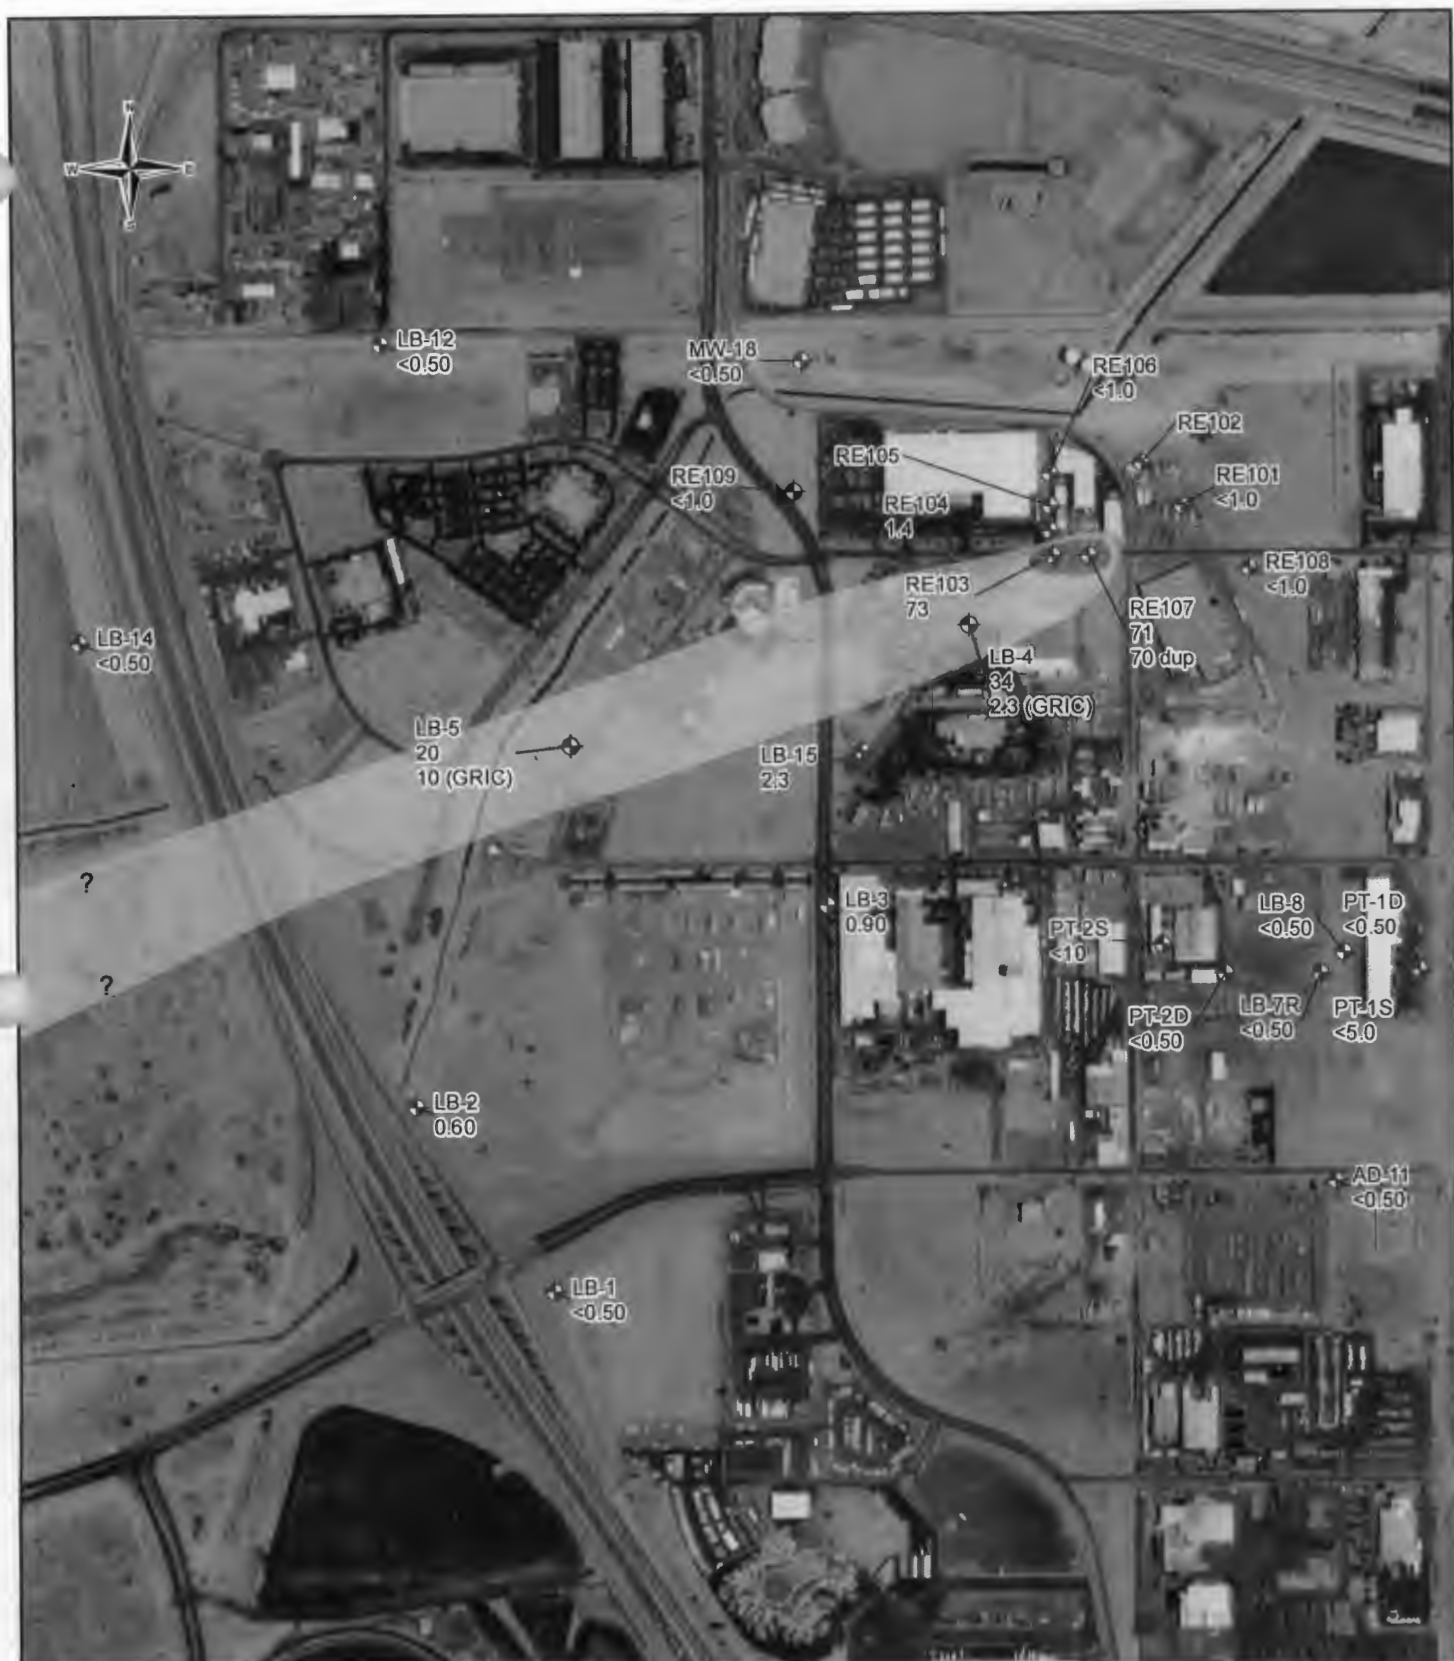
PCE Concentration – Lone Butte Industrial Park Area (July - August 2010)
